Case Studies

Case Numbers | 102, 105, 111, 113, 121, AJ-GW 1, AOP-GW1, AOP-GW2, AOP-GW3, AOP-GW4, 1187034

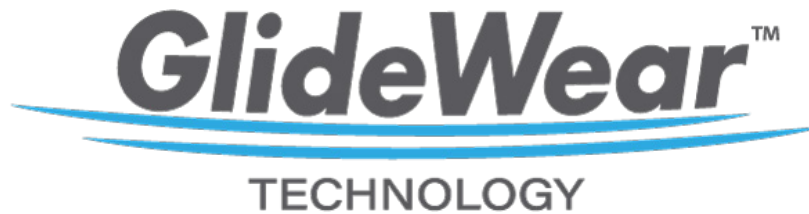
GlideWear™ improves user safety and comfort by helping prevent and heal soft tissue damage. GlideWear is a patented silk-like two-layer fabric, manufactured by Tamarack Habilitation Technologies, designed to protect skin and soft tissue from the damaging effects of rubbing/friction.

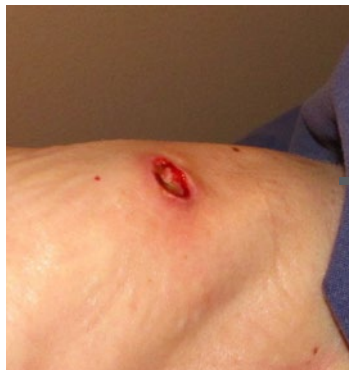
Decubitus ulcer, stage III
caused by orthotic corrective
pad at right thorax.

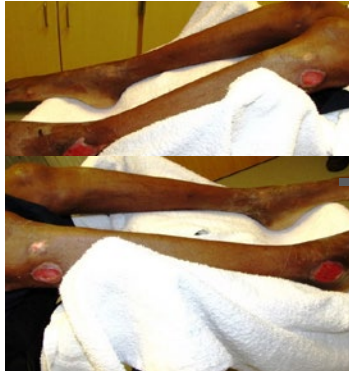
Multitude of decubitus ulcers stage III at the lower extremities caused by night time bed positioning.

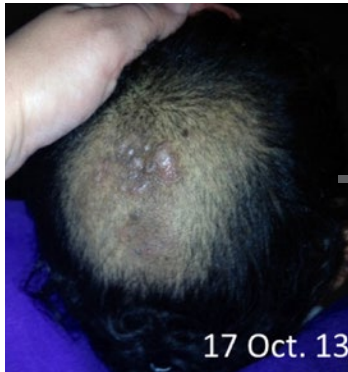
Inflammation, callus and blistering formation on back of head. Severe hair loss.

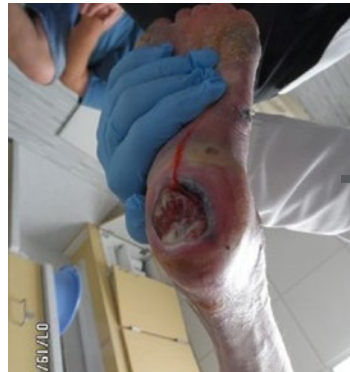
Decubitus ulcer, left heel, stage II.

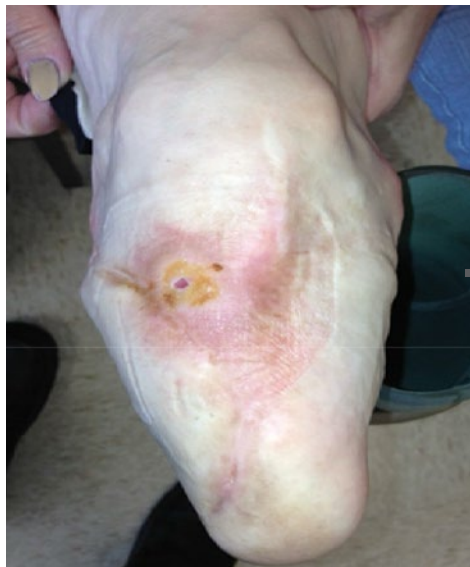
Wearing GlideWear patch full time.

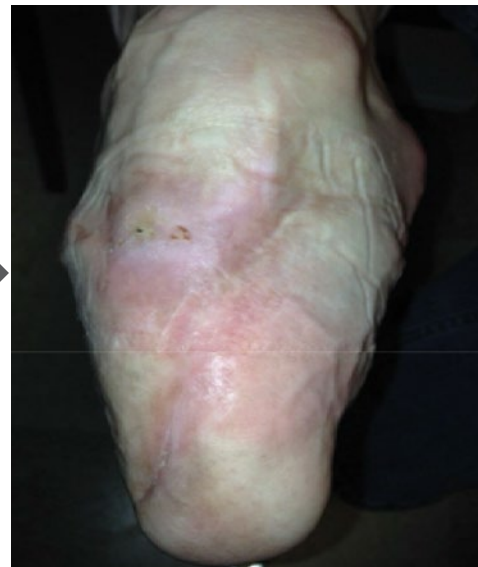
Wearing GlideWear patch full time.

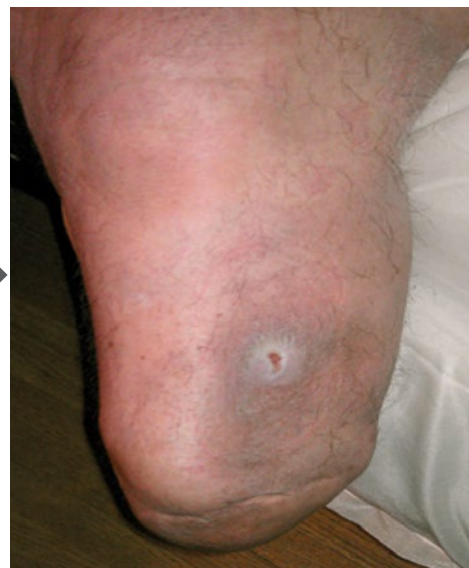
Patient is placed in a casting liner with GlideWear patches to start daily use of patches. Replacement liner is ordered.

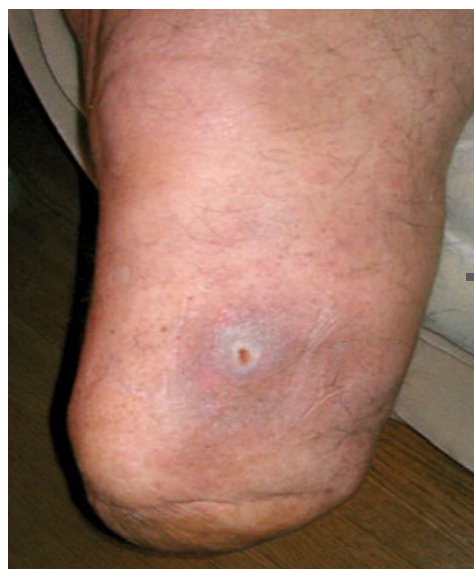
GlideWear patch is being worn full time.

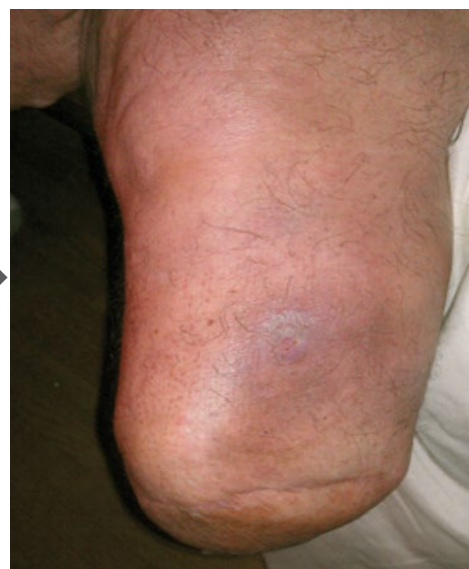
GlideWear patches being worn full time.

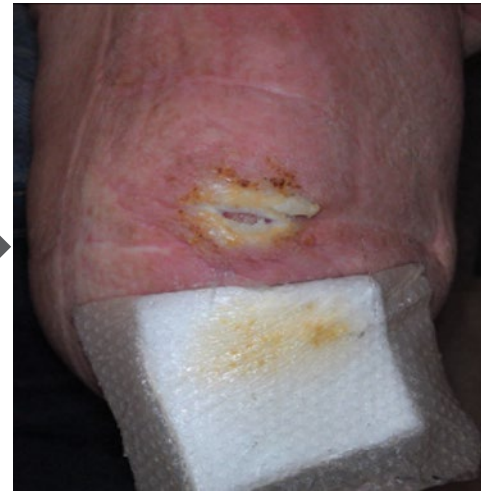
Pads are placed in anterior socket and proper sock ply is established with patient. GlideWear patches are placed in gel in for full time use. Patient is retired, but still is active around his home.

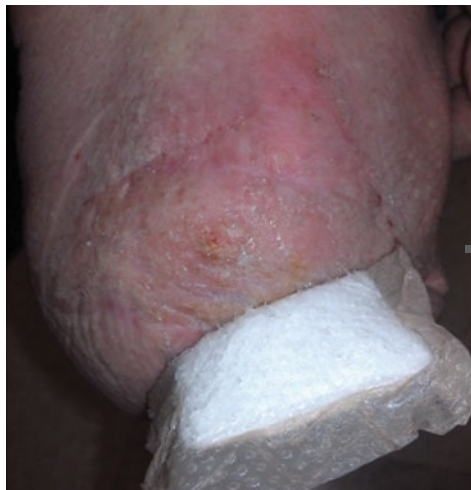
Patient is using GlideWear patch full time in prosthesis.

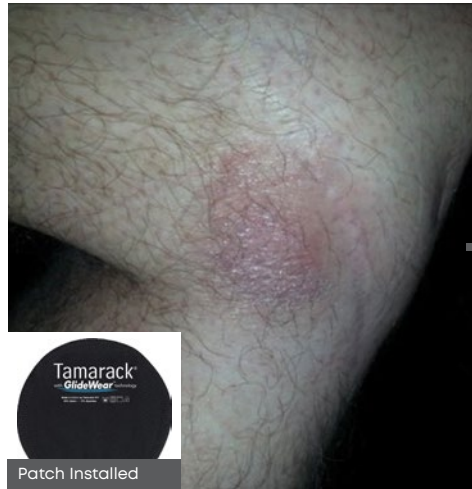
[CLICK TO LEARN MORE](#)

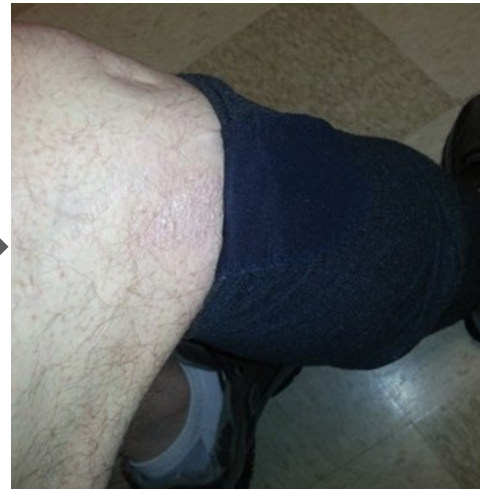
GlideWear patch worn full time.

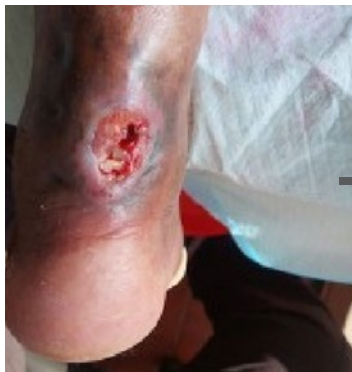
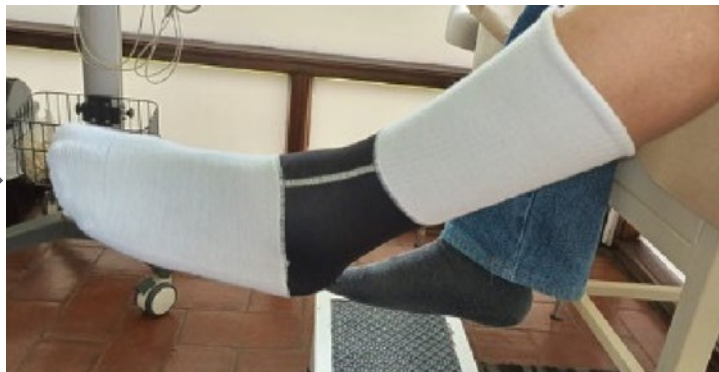
Condition
Decubitus ulcer, stage III

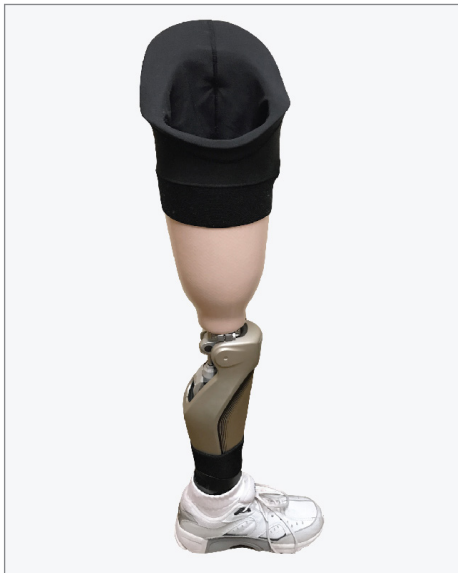
The following products incorporate GlideWear Technology in strategic areas to protect users from friction and shear forces that result in painful and debilitating soft tissue damage such as blisters, ulcers, sores, and pressure injuries.

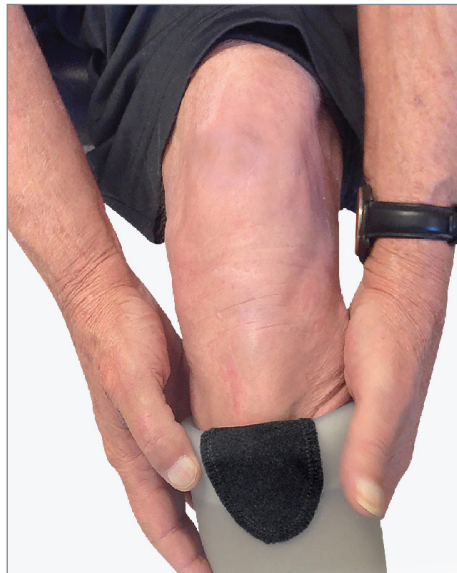
Tamarack™ GlideWear™
Brim Sheaths

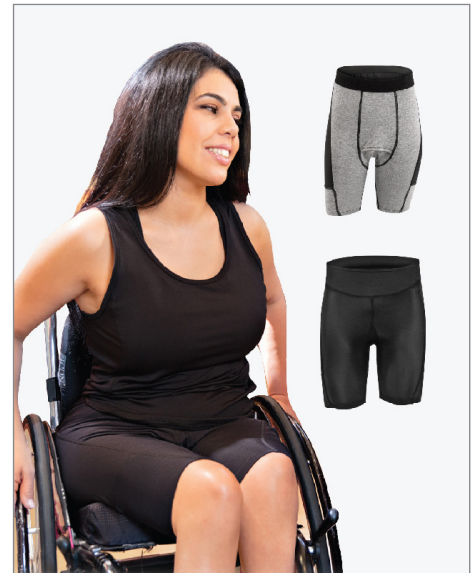
Tamarack™ GlideWear™
Prosthetic Liner Patches

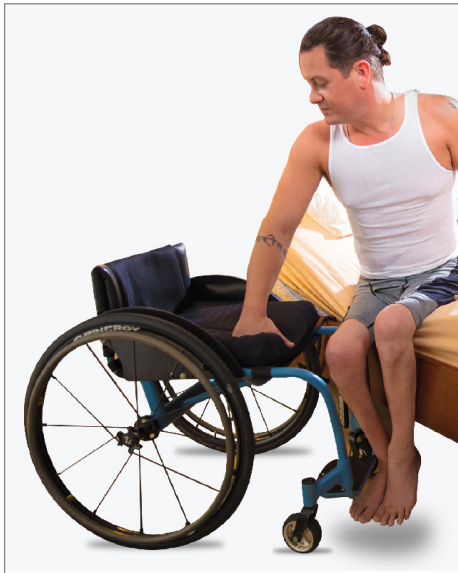
GlideWear™ is a patented, two-layer, ultra-low-friction fabric that protects skin from harmful friction and shear. It reduces factors (friction, shear, microclimate) that contribute to pressure injuries (pressure ulcers, pressure sores, or bed sores), diabetic foot ulcers, and other tissue and skin damage. GlideWear™ is widely used in medical and sports applications. Feel GlideWear™ for yourself!
